# CASE STUDY

ARMORMAX® Anchored Reinforced Vegetation  
Penn Levee Armoring  
Jefferson Parish  
Lafitte, LA

## ARMORMAX® STANDS UP TO HURRICANE GUSTAV AND IKE

PROJECT ▶ PENN LEVEE

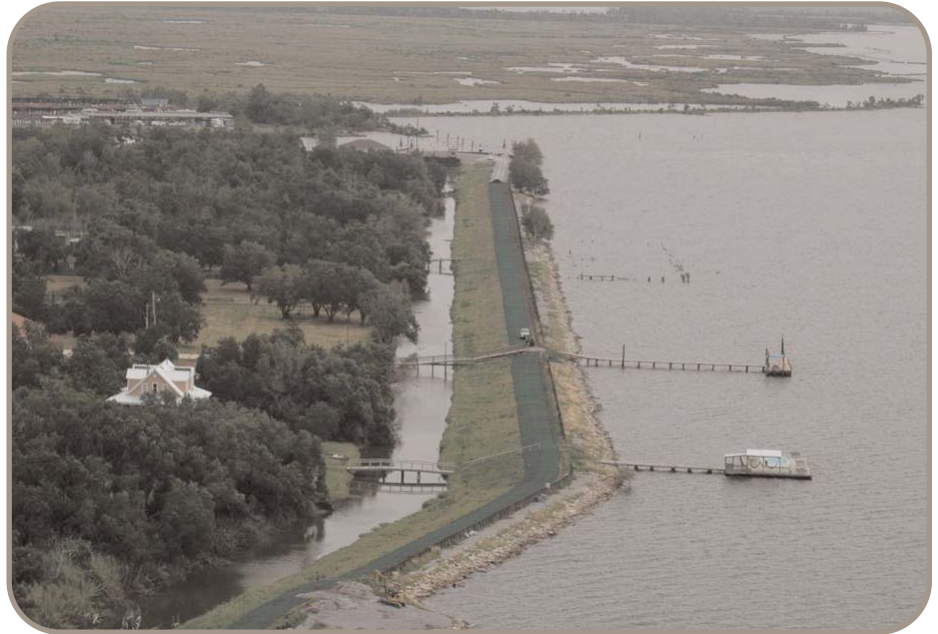
*Penn Levee Phase I installation completed summer of 2007*

The design for the 1.8 mile (2.90 Km) long Penn Levee included the use of the ArmorMax system to armor the levee crest (top) and down the backside slope to the Borrow canal. The project was installed in two phases. Phase I installation was completed in July 2007 with the ArmorMax system installed starting 5 feet (1.52 m) from the sheet pile wall to 18 feet (5.49 m) across the levee crest. Phase II installation started in May 2008 and started where Phase I ended 25 feet (7.62 m) down the back side of the slope. Prior to installation the levee was prepared by "scalping" the vegetation with a mower and then back-dragging it to fill in any depressions and remove any obstructions. The HPTRM component was then installed and secured with Type 2 earth percussion anchors in a checkerboard grid pattern at five feet (1.52 m) centers. The earth percussion anchors act as a tie-down mechanism with 500 lbs (227 Kgs) of maximum pull-out strength for greater factors of safety. The ArmorMax installation in both phases was complete in 6 weeks each time versus typical installation of rock riprap which could take 4 to 5 months. "This is a great product for levee reinforcement. We can install ArmorMax in a very short period of time, which is extremely important for levee construction and armoring," said Ray Reiser, , owner of River West Construction, which was responsible for the product's installation. The DeCamp Street Levee had an additional 1,300 feet (396.24 m) of ArmorMax installed from the front toe of the levee over the crest and down to the backside toe.

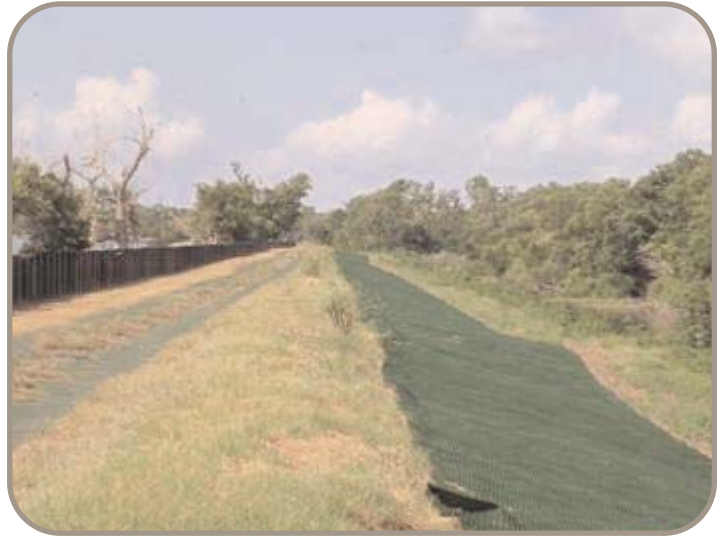
*Phase II installation was completed July 2008*

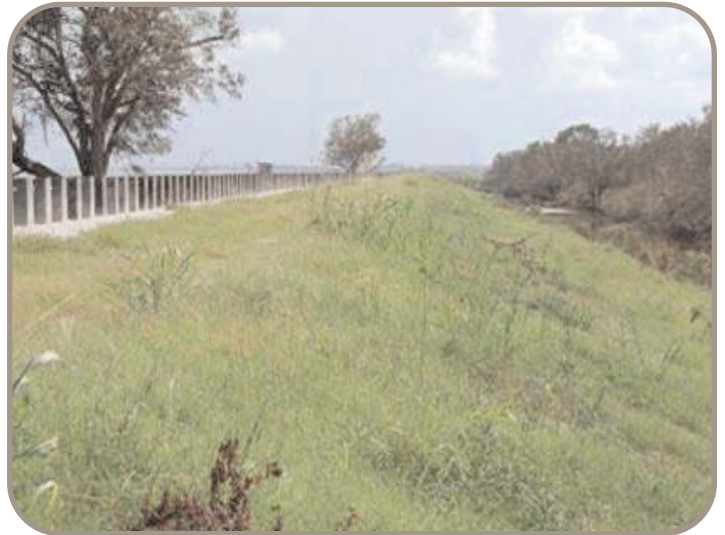
*Five weeks of vegetation growth after Phase II installation*

Just five weeks after installation the ArmorMax system was put into action. Hurricane Gustav made landfall on September 1st, 2008 along the Louisiana coast subjecting the Penn levee to heavy rainfall. A few weeks later, Hurricane IKE battered the Penn Levee with up to a 12 foot storm surge (3.66 m) putting the ArmorMax system to the ultimate test.

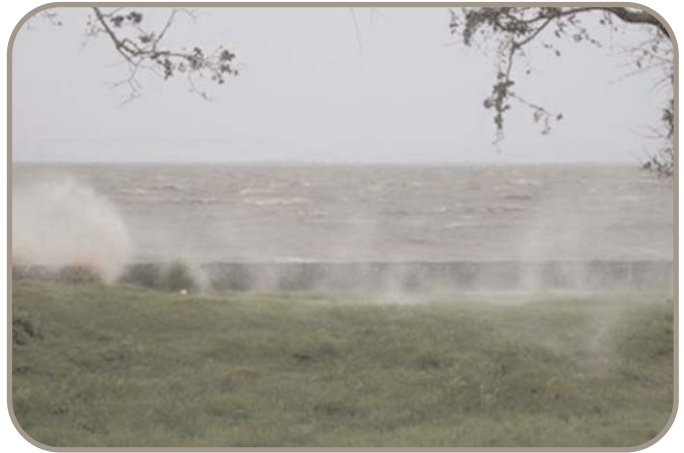
*Hurricane IKE Storm Surge at 3:17 pm*

At 3:17 pm IKE generated 6 foot swells that pounded Penn Levee. Water on the backside of the levee began to rise and wave action created overtopping. Just over three hours later at 6:22 pm, the top of the levee experienced consistent, concentrated flow of water with significant erosive capabilities. Water on the back side of the levee rose nearly to the top. Only four hours later at 7:14pm, the ArmorMax system took the full force of waves generated by Ike as the water level rose 8.5 feet, submerging the levee to within 6 inches of the top of the sheet pile wall.

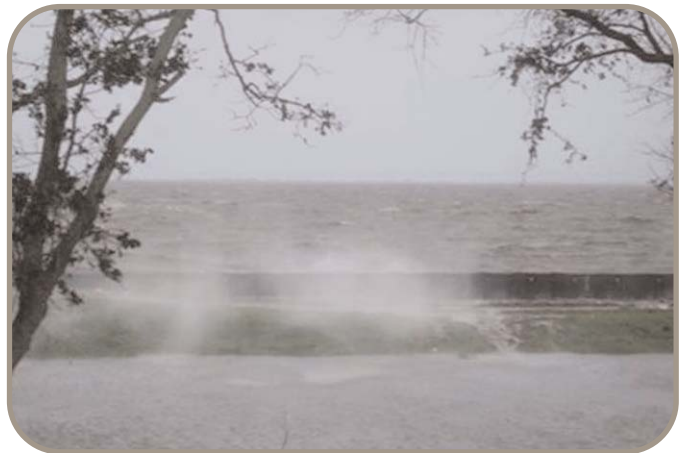
*Hurricane IKE Storm Surge at 6:22 pm*

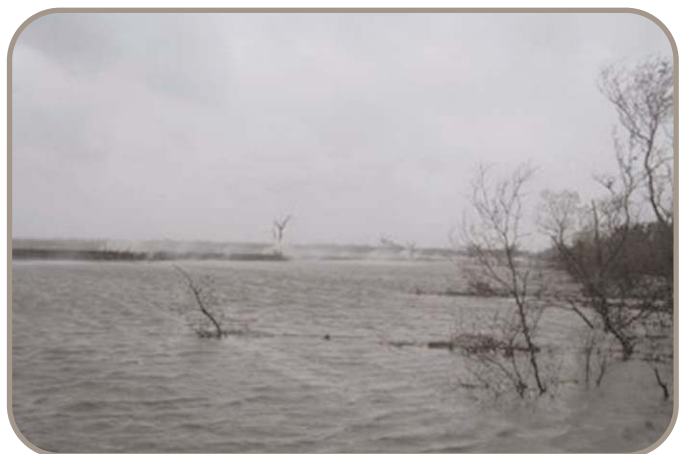
*Penn Levee completely submerged at 7:14 pm*

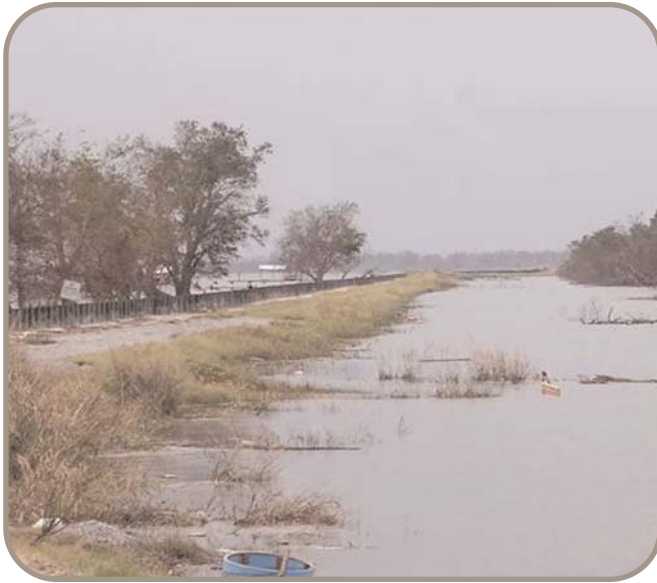
*Three Days After IKE Storm Surge & Flooding*

Three days after IKE up to 80% of the levee was still submerged with significant amounts of debris in the water, over a foot in some areas, continuing to stress the armoring system. The ArmorMax system continued to hold and protect the levee, even with the debris, because of the superior tensile strength of the high performance mat. The debris was unable to penetrate and tear the mat which is important for it to work over a long period of time. Even in areas where the vegetation had yet to take root, the Armormax was able to literally "hold its ground", and prevent erosion and scouring from taking place on the levee, preventing it from breaching or completely failing.

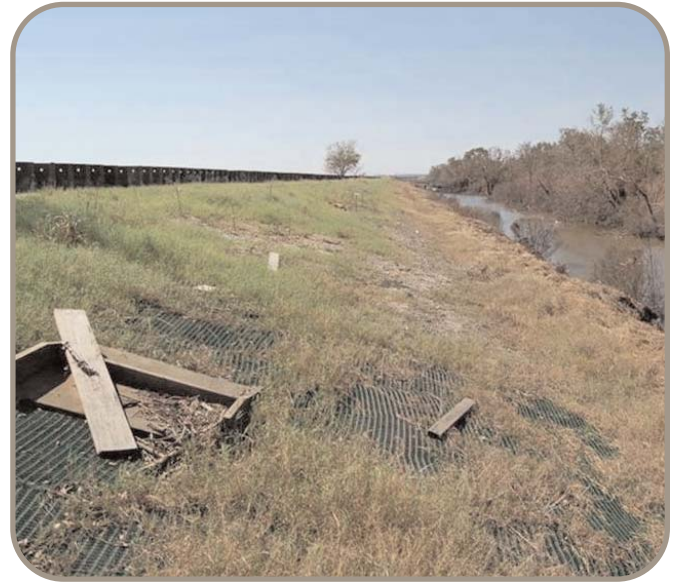
*ArmorMax System Withstands Debris Loading from IKE*
